WATER RESOURCES INVESTIGATION

*MILLER RUN and AYERS BROOK
VERMONT
CONNECTICUT RIVER BASIN*

SITUATION REPORT

SEPTEMBER 1976

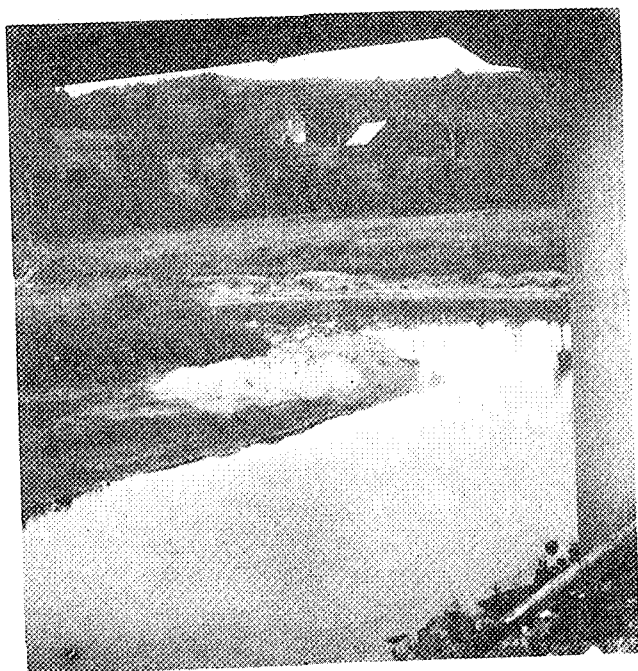
Fig. IV - 3

The brook then flows through a row of trees and heavy brush which border the flat open fields adjacent to Route 122. Continuing downstream the stream momentarily parallels Route 122 at its intersection with Interstate Route I-91 (Fig. IV-3) then turns and heads out around the open fields. From this point to the covered bridge on Route 122, the stream meanders depositing sand and gravel on the inside of bends eroding farmland on the outside of bends. Access to these areas for a removal operation is fairly easy but only small amounts of material can be found at each location. No serious flood problems exist in this area.

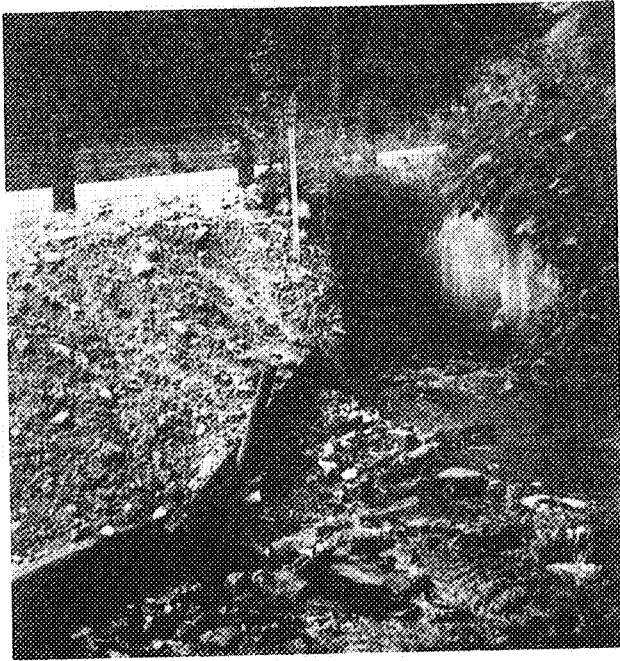
Fig. I - 9

Zone I of Ayers Brook begins in Brookfield Gulf and ends at its confluence with Open Meadow Brook. In the upper reaches of Zone I the brook is quite small, often hidden amongst the tall ferns and heavy brush. The brook follows closely the course of State Route 12 with the base of the roadway embankment forming one side of its channel (Fig. I-1 to I-8). During high flows, the gravel material along the shoulder of the road often washes away and frequent repair work is required by the State of Vermont (Fig. I-3, I-8, and I-15). The brook crosses Route 12 several times along the Allis State Forest Park. Two of these crossings are shown in Fig. I-9 and I-10.

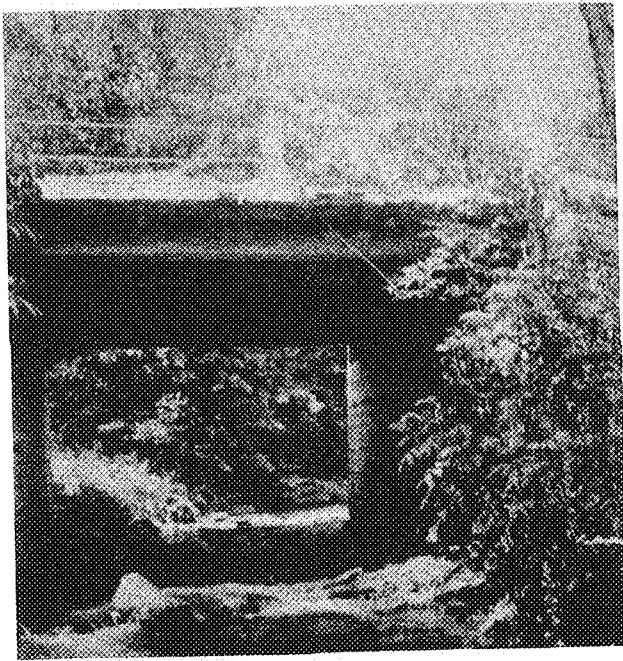
Fig. II - 1

Zone II of Ayers Brook begins at the confluence of Open Meadow Brook and ends where Tributary G joins Ayers Brook. Looking upstream at Open Meadow Brook (Fig. II-1), the brook crosses Route 12 and flows for approximately 1,000 feet to its confluence with Ayers Brook. The bridge, 50/12, is structurally sound, but the concrete decking is in need of repair.

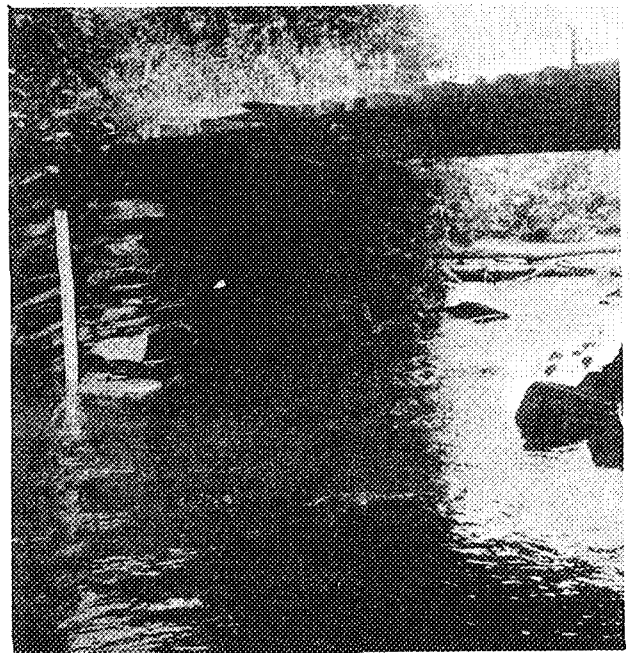
Fig. II - 4

Just downstream of the confluence with Open Meadow Brook, Cold Brook descends from Mt. Nevins, crosses Route 12, and joins Ayers Brook. The brook then flows southerly to an unpaved road which intersects the brook in an undeveloped area about 1500 feet from Route 12. Upstream of this crossing (Fig. II-2), fallen trees and small gravel deposits are found on the inside of all bends. Downstream of the bridge (Fig. II-3) the stream gradient increases and except for a few fallen trees, the channel is relatively clear. The bridge, constructed of stone with a wooden decking (Fig. II-4) appeared to be unstable.

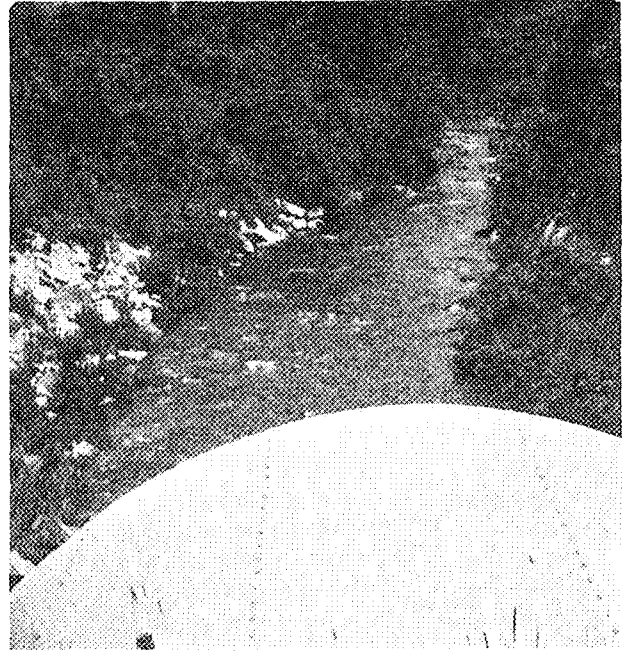
Fig. II - 10

After its confluence with Tributary D, Ayers Brook continues southward flowing through the corrugated metal arch pipe (Fig. II-10 and II-11) under Route 12. No problems were observed in this area or immediately downstream of the bridge (Fig. II-12). However, about 1000 feet downstream of the bridge, Ayers Brook has begun to shift its

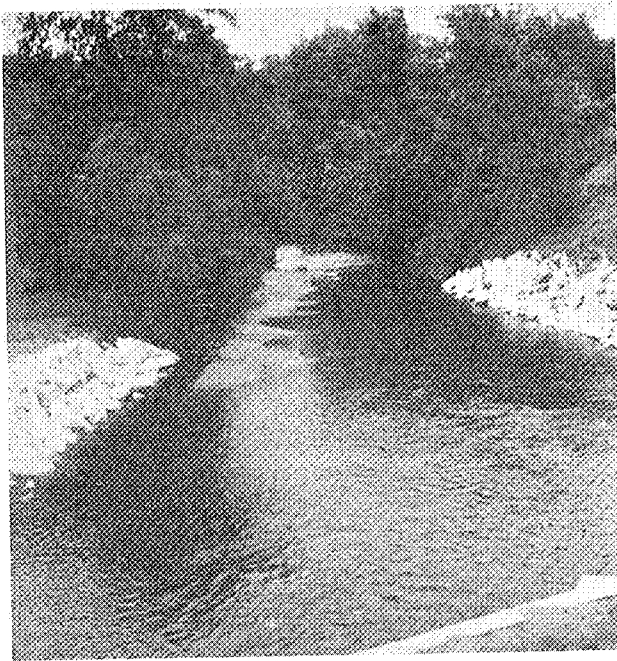
Fig. IV - 5

Downstream of the new bridge (Fig. IV-5) there is stone protection on either side of the brook for a distance of 150 feet. Continuing downstream, small deposits of gravel are located at bends with only one rather large one just downstream of the Route 66 bridge (Fig. IV-7) being of potential harvest value. No significant problem areas were found in this area.
